Quarterly Report

FEBRUARY 2017 – APRIL 2017

Afghanistan Reconstruction Trust Fund

SUPERVISORY AGENT: Management Systems International

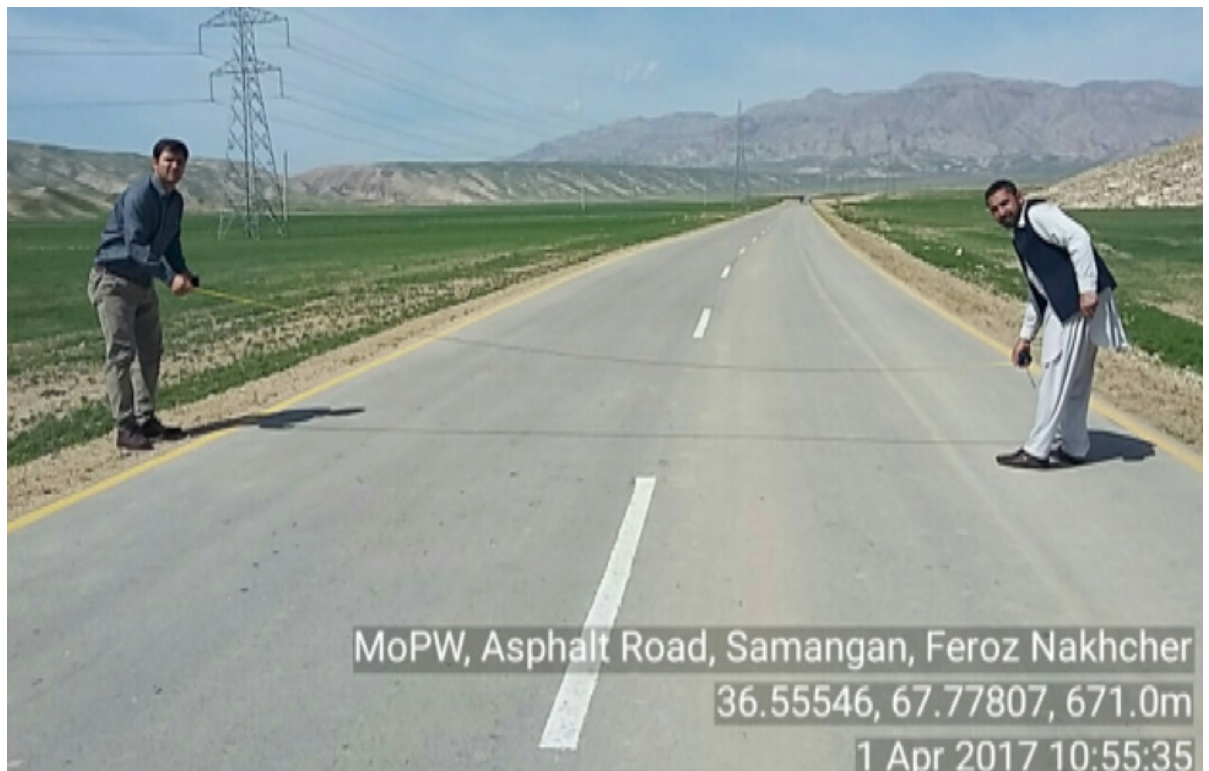
FIGURE 7
Samangan Province,
Feroz Nakhcher
District, Sayad to
Feroz Nakhcher
Road (MSI-AR-0141).

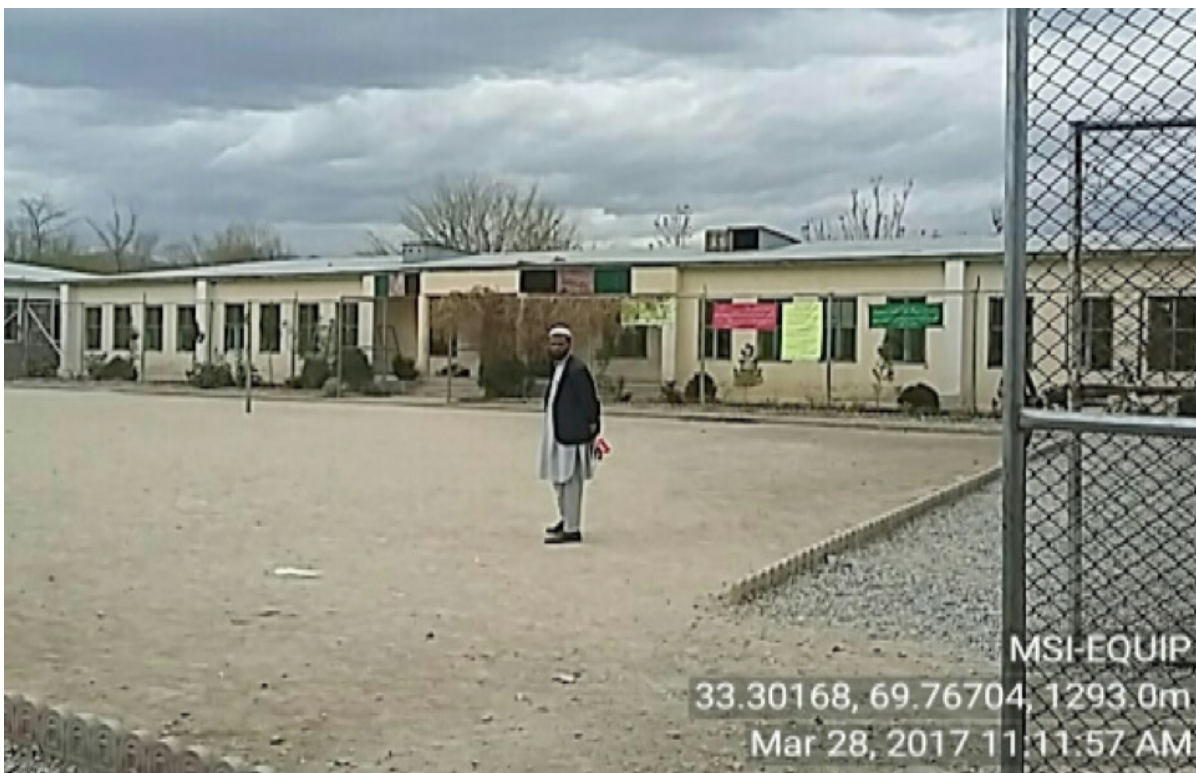
FIGURE 8

Khost Province,
Mando Zayi
District, Mita Khan
High School
(MSI-EQ-1034).

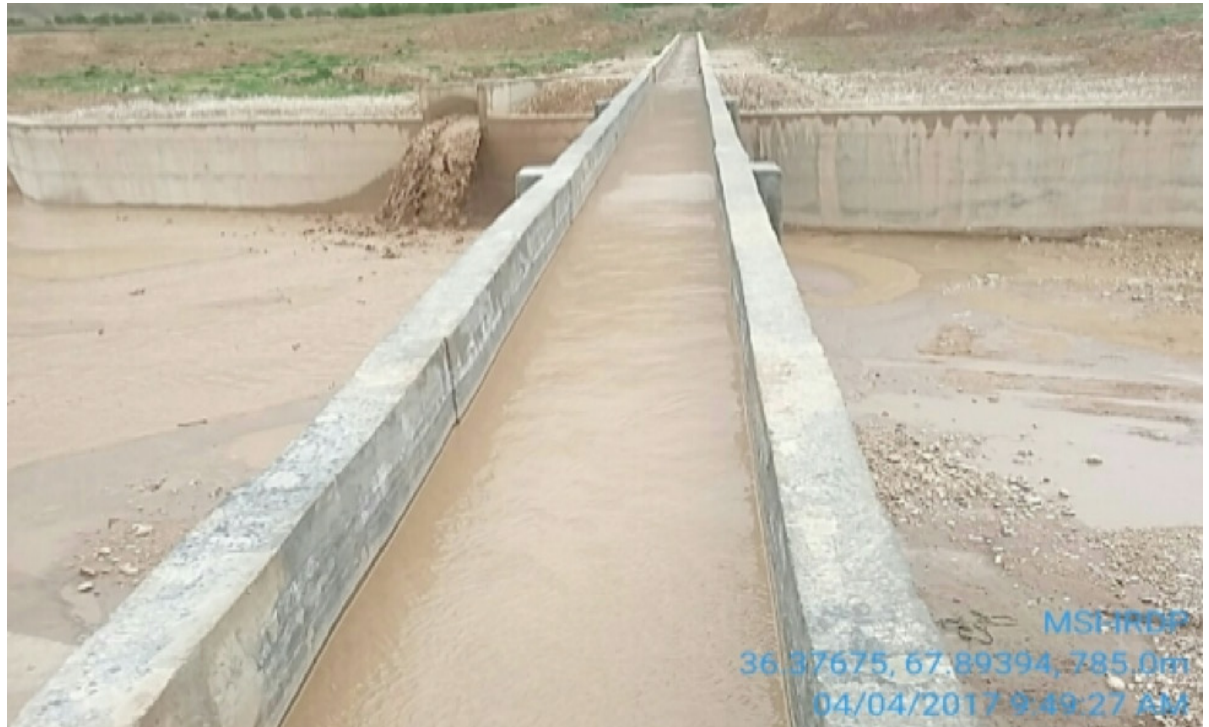
FIGURE 9
Samangan Province,
Hazrat Sultan
District, Asiabad
Canal Irrigation
Scheme Phase III
(MSI-IRDP-0325).

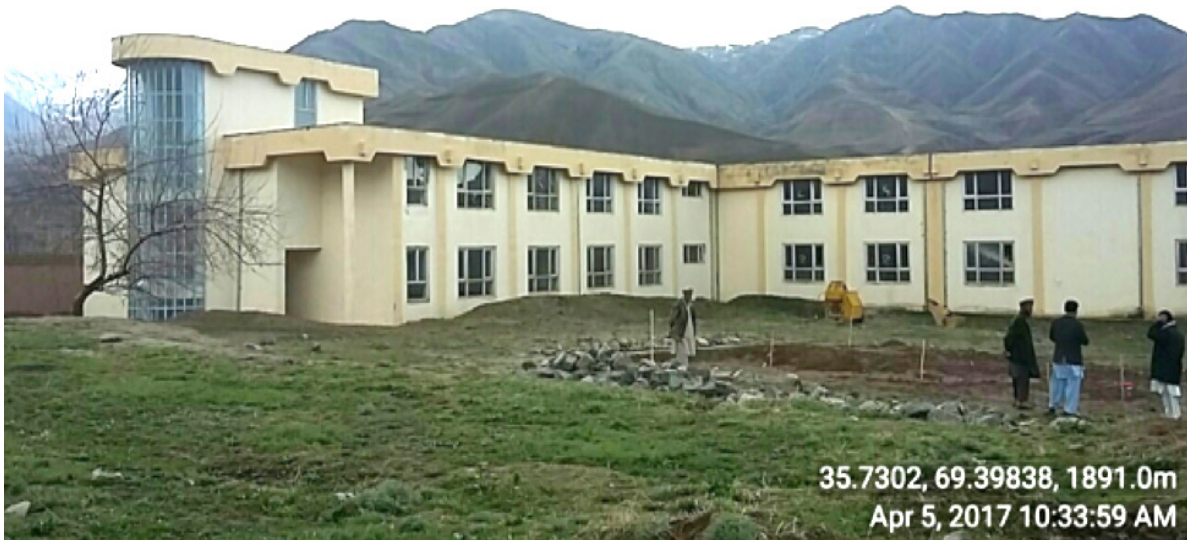
FIGURE 10

Baghlan Province,
Dih Salah District,
Qasan Boys High
School, MSI-NS-
92277-DSCRW

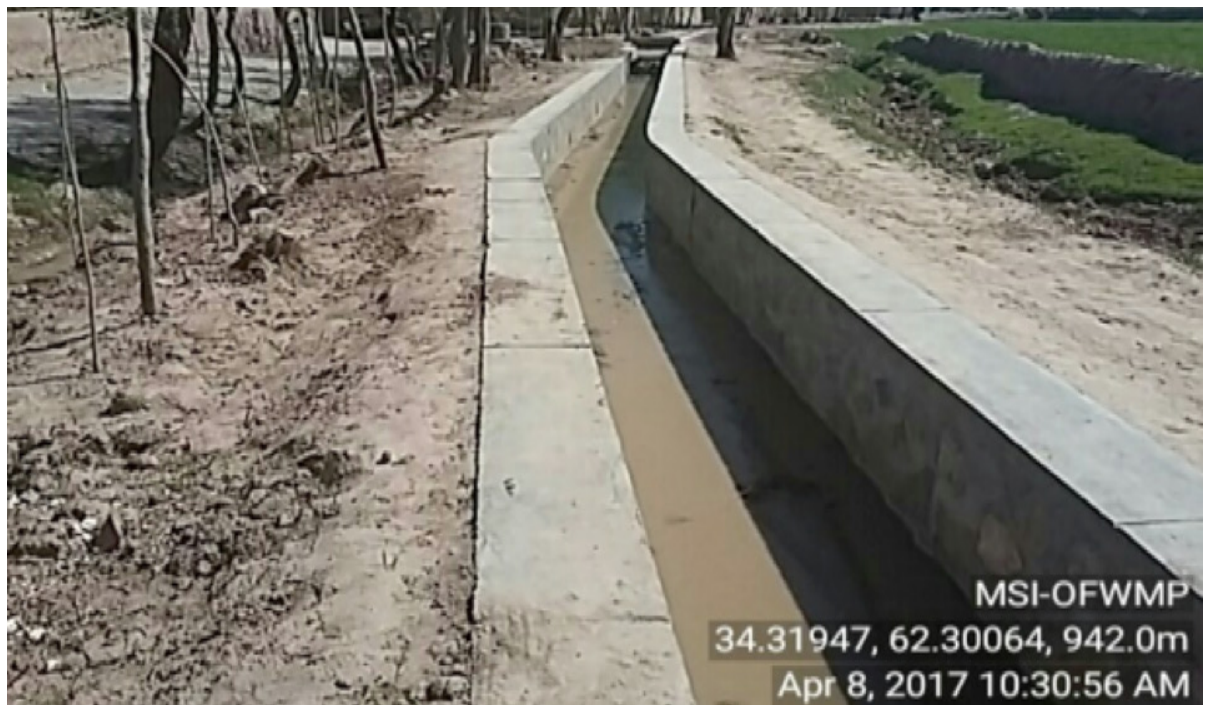
FIGURE 11
Herat Province, Injil District, Urdokhan Irrigation scheme (MSI-OFWM-183)

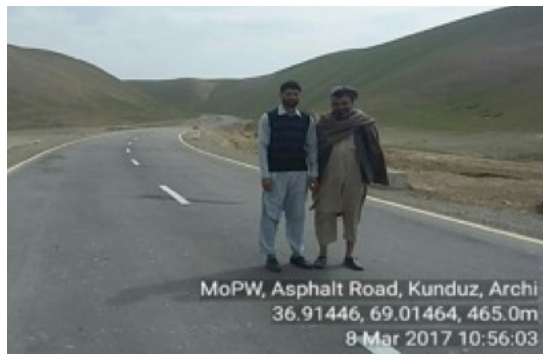
MoPW, Asphalt Road, Kunduz, Archi
36.91446, 69.01464, 465.0m
8-Mar-2017 10:56:03
